# FIELD HOME FINAL REPORT

## Yorktown Heights Field Home

(Yorktown, NY)

30 December 2025

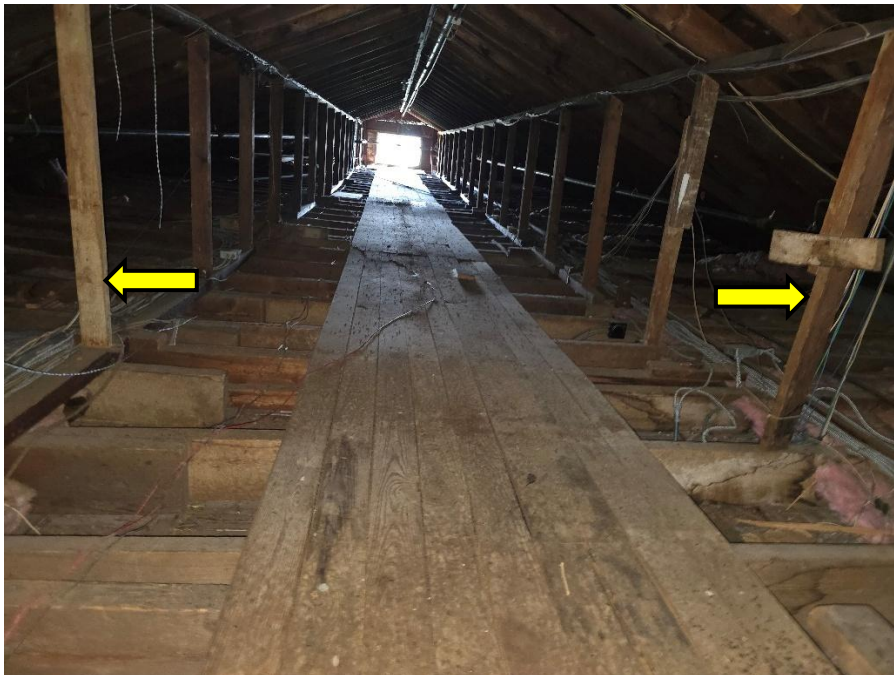
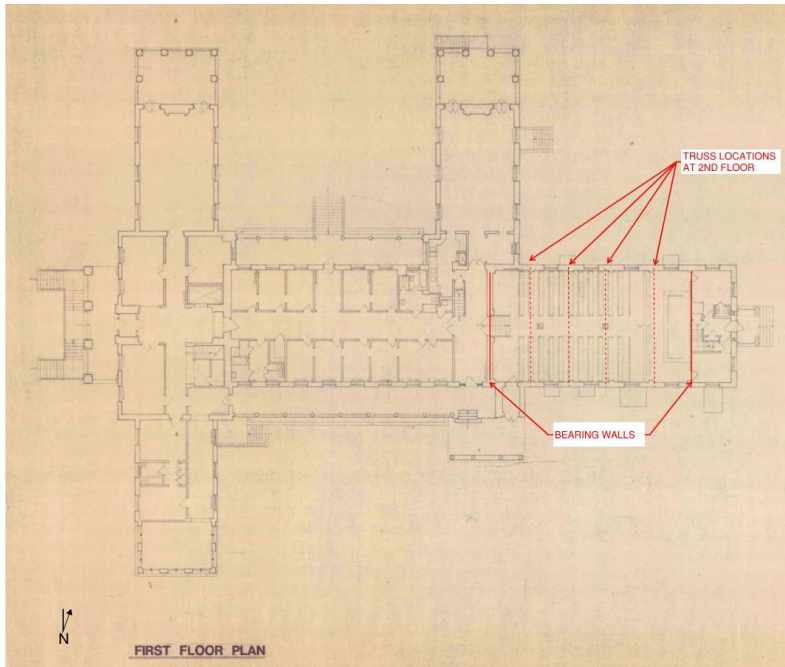
The corridor walls of the second floor were bearing walls supporting the low-slope portion of the gambrel roof and the second-floor ceiling joists, based on IMAGE 20250827\_112811. Studs supporting the low-slope roof were spaced at every other ceiling joist. Ceiling joists measured 8 ½ inches by 2 ¾ inches and were spaced approximately 24 inches apart. No walls or columns were present in the chapel space beneath the corridor walls above to continue the load path, nor was there evidence to suggest such structural elements ever existed, given the intended use of the space.

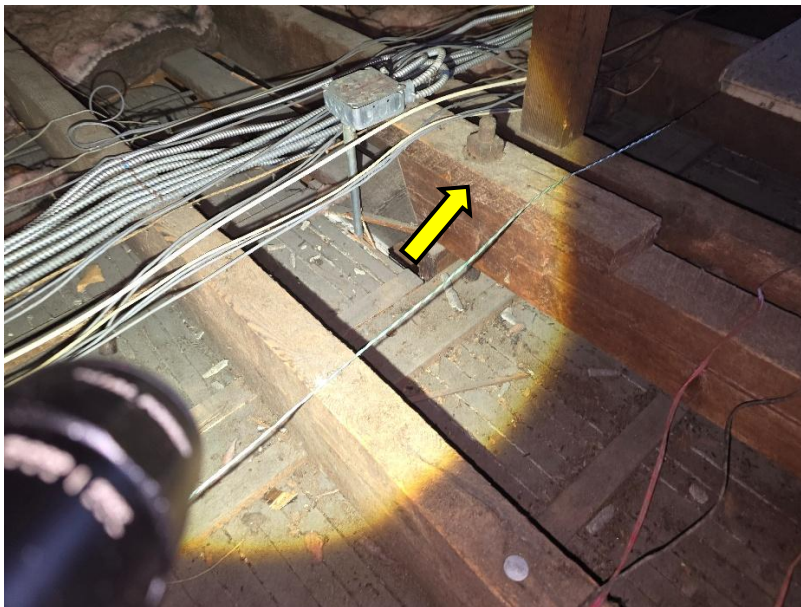
In the attic, what appeared to be hanger rods and diagonal chords were encountered intermittently, aligned with transverse walls below, based on IMAGE 20250827\_113051. It was assumed that trusses were buried in the transverse walls to support the corridor walls at the second floor. Chord members observed were measured to consist of 4x6 timber. A sketch was provided to depict the assumption made of the intermittent trusses.

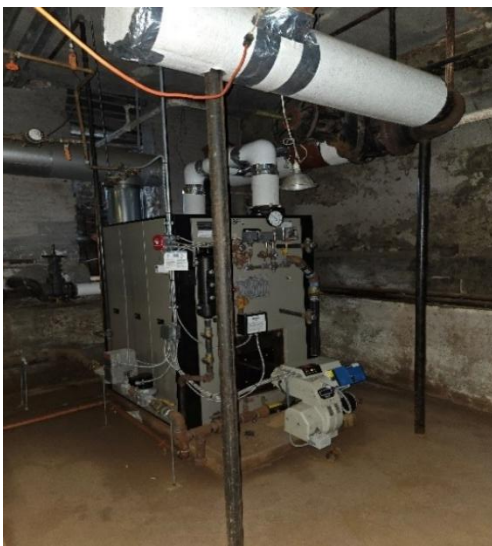
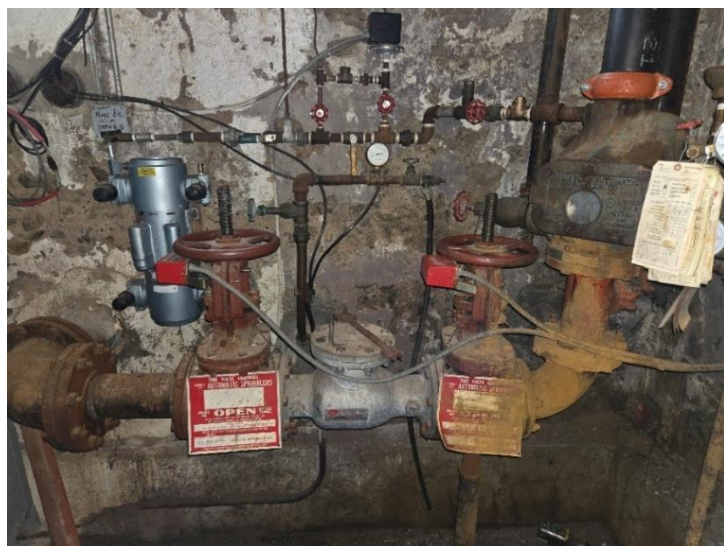
### Mechanical Systems

While a new boiler was installed 3 years ago, it is not known if the existing heating and radiator is operational in its entirety. There is an older high pressure steam system that has been decommissioned and largely left in place.

There is no central cooling system. Individual window air conditioners and a small number of mini-splits have been utilized on a limited basis. There is no independent or centralized ventilation system and the building relies on largely passive ventilation measures.

For the purposes of planning for a new adaptive re-use of the building, it is the conclusion of the Beardsley team that entirely new Heating and Cooling systems are required, from major source equipment to all distribution systems and point-of-delivery ceiling and floor devices.

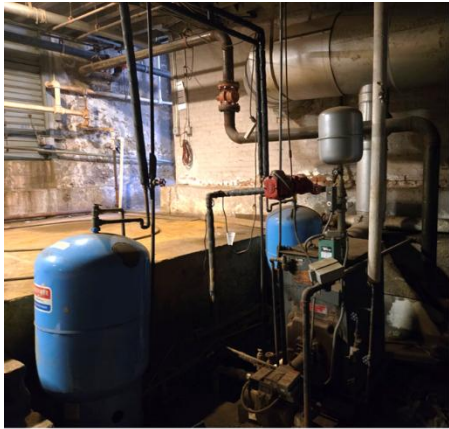
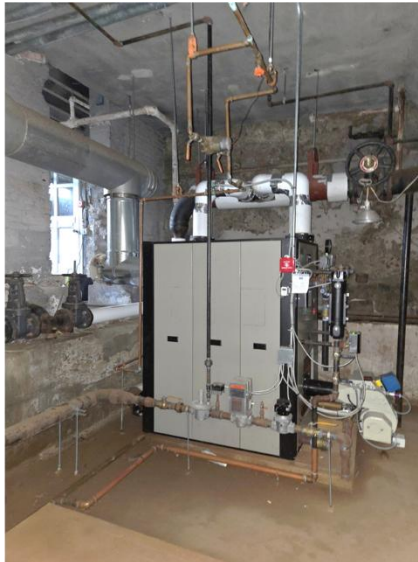
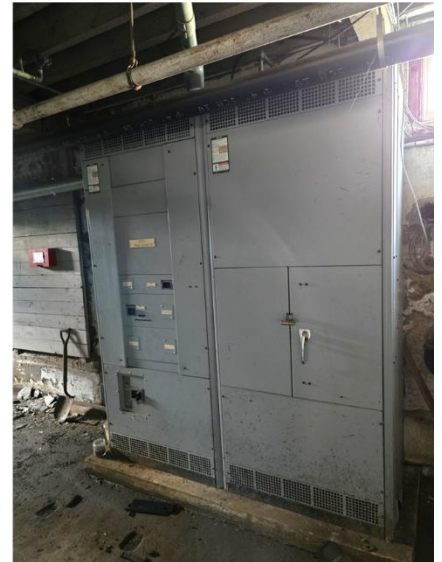
## **Electrical Systems**

The electrical system in general is operational and appears to have been upgraded over the years. There are no indications of older, non-compliant wiring and panels still in use. All vintage-and-tube wiring appears to have been removed and replaced with romex and armor cable wiring.

The electric service appears to have been upgraded and increased over the past 10 to 20 years and features multiple points of service. An exterior diesel emergency generator on the northeast corner of the building is not functional.

With the exception of several decorative chandeliers and wall sconces, there are few lighting fixtures that are considered salvagable.

For the purposes of planning for a new adaptive re-use of the building, it is the conclusion of the Beardsley team that entirely new electrical wiring is required, from major source equipment to all distribution wiring, panels and outlets. A new emergency power generator will be required dependent on the final new building use.

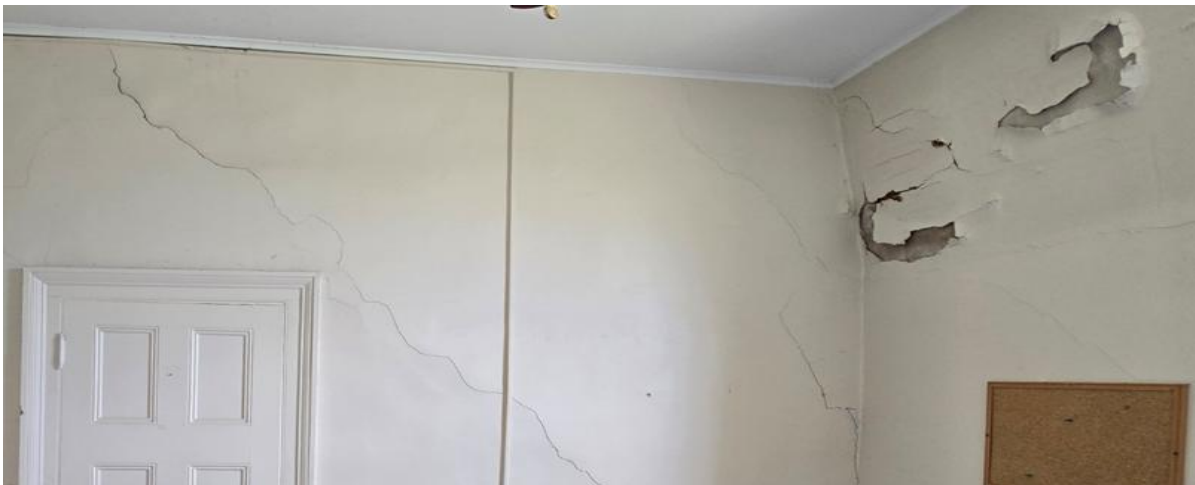
#### **Walls**

Exterior walls are original unreinforced concrete that varies in thickness from 18” to 24”. In general, the walls are in good condition and show no signs of structural cracking or failure. The interior finishes are in good condition with the exception of a few limited areas of water damage. The interior walls in the Chapel require significant repairs. The exterior plaster/stucco finishes are showing signs of cracking and require a moderate amount of repair.

The site visits and inspections did not allow for a clear determination of the complete wall assemblies and it is suspected that there is limited insulation in the exterior walls. It is likely that an adaptive re-use will require additional insulation to achieve compliant R-values for current NY energy code.

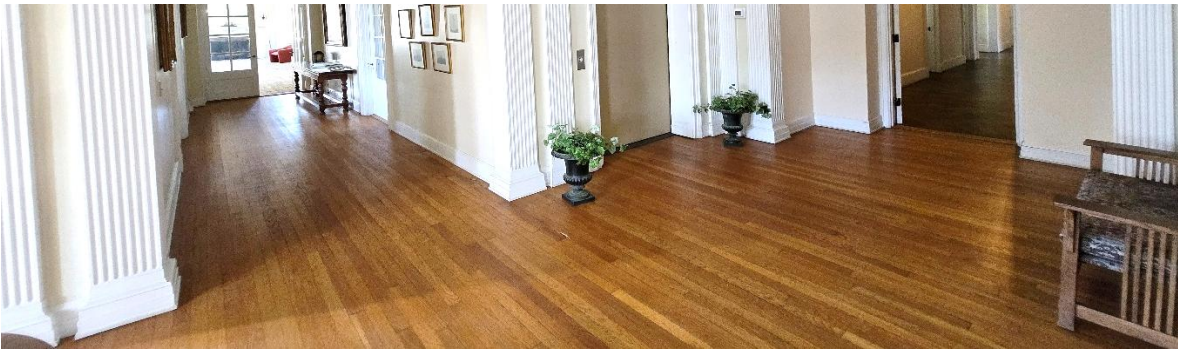
## Flooring

The majority of interior flooring is original hardwood flooring over wood sheathing and floor joists. The visible wood flooring is in good to excellent condition. In some areas, new wall-to-wall carpeting has been installed. Basement flooring is primarily exposed concrete. It is recommended that the wood floors are refinished and that the concrete floors are power-washed, sealed or painted. All floors require minor spot repair as required.

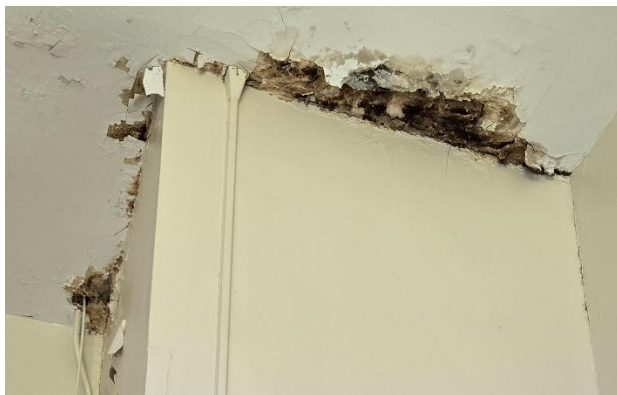
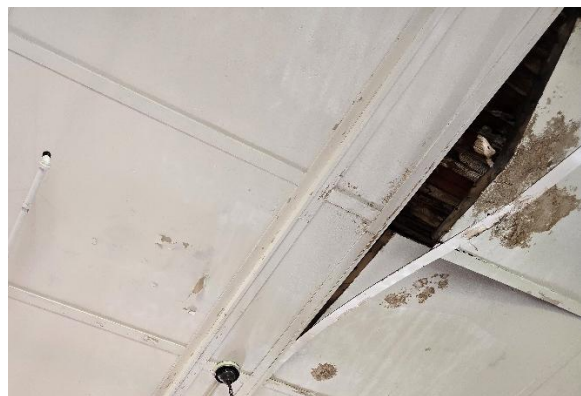
## Ceilings

The majority of the existing ceilings are hard plaster or gypsum on underlying lath or wood slats. Most are in good condition and only require cosmetic repair. There are a limited number of ceiling lights, mostly decorative chandeliers.

There are some lay-in acoustic ceiling tile (ACT) ceilings in back of house areas that, with some possible exceptions, require full replacement. Most of the 2x2 and 2x4 fluorescent troffer lights are also candidates for replacement.

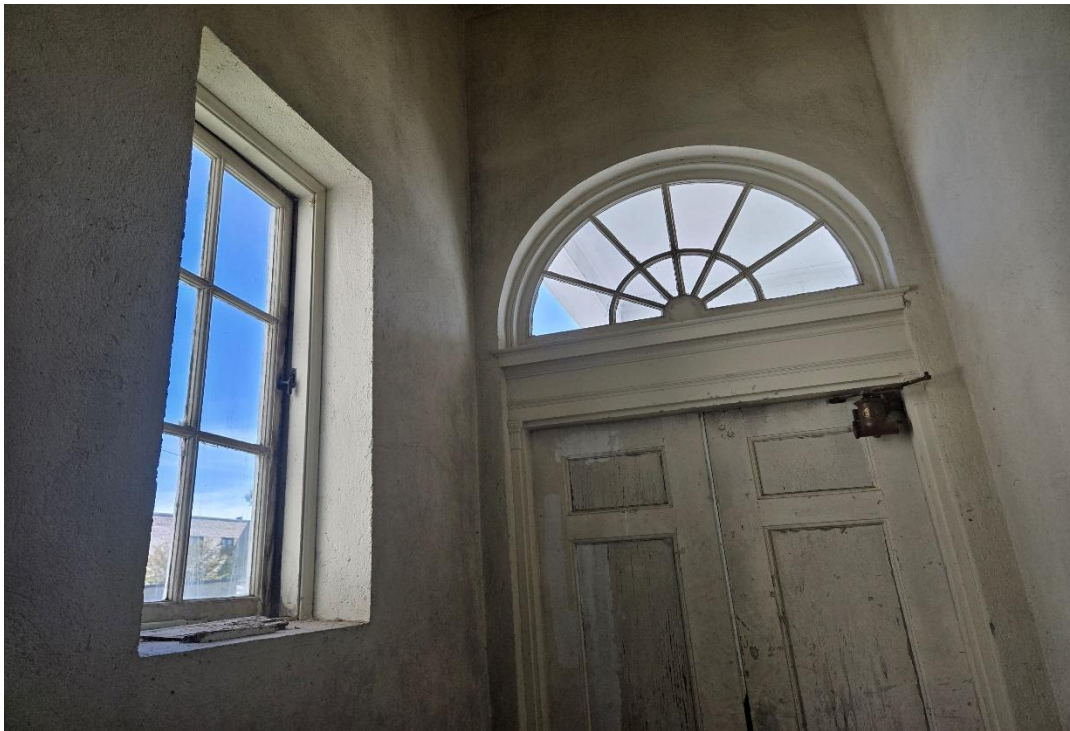
### Doors / Windows / Skylights

The majority of interior and exterior doors appear to be original and in good condition with some in need of minor repair. All require cosmetic upgrade and re-finishing or re-painting.

With the exception of the Chapel, nearly all of the original windows have been replaced with newer replacement aluminum windows equipped with storm windows and screens. They are not true divided light windows and would not be eligible for historic restoration (they have faux muntins sandwiched between two glass panes). It is unclear how old the windows are. The expected life of new double pane thermal windows is approximately 25 years. Based on appearance and workmanship, they appear to be lower end to moderate grade replacement windows with thin aluminum profiles. The seals and air gaps may be compromised and not as energy efficient as new windows. Given the unknown age and performance of the windows and the overall aesthetic incompatibility with the buildings historic character, it is recommended that be replaced.

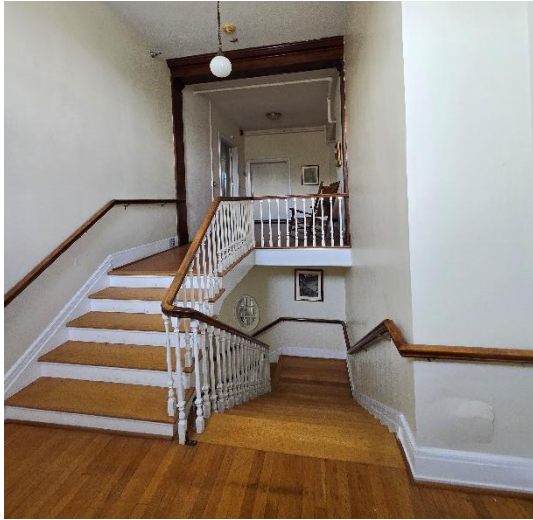
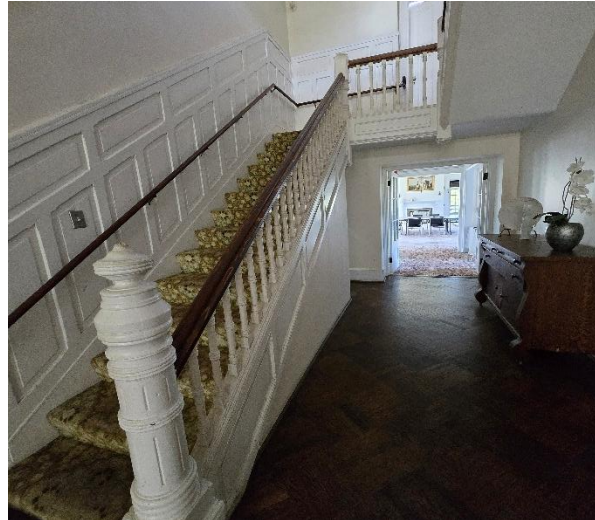
## Interior Stairs

There are two main open stairs at the west end and center of the building and one smaller closed stair at the east end of the building connecting to the Chapel. The stairs are wood construction and are in good condition. Note: the two main open stairs are not fire rated and will likely require a rated separation to meet new code requirements for adaptive re-use.

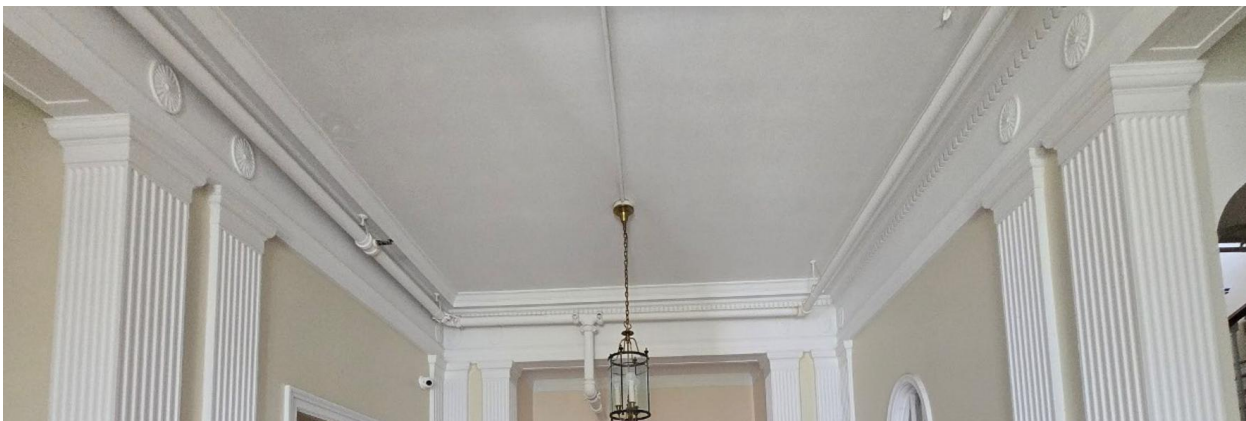
## Interior Trim and Ornamentation

Interior wood trim including crown molding, chair and picture rail, dentils, etc. is generally in good condition and requires minor repairs and cosmetic upgrades. The majority is located on the first floor. Note: The trim and ornamentation in the Chapel require significant repair.

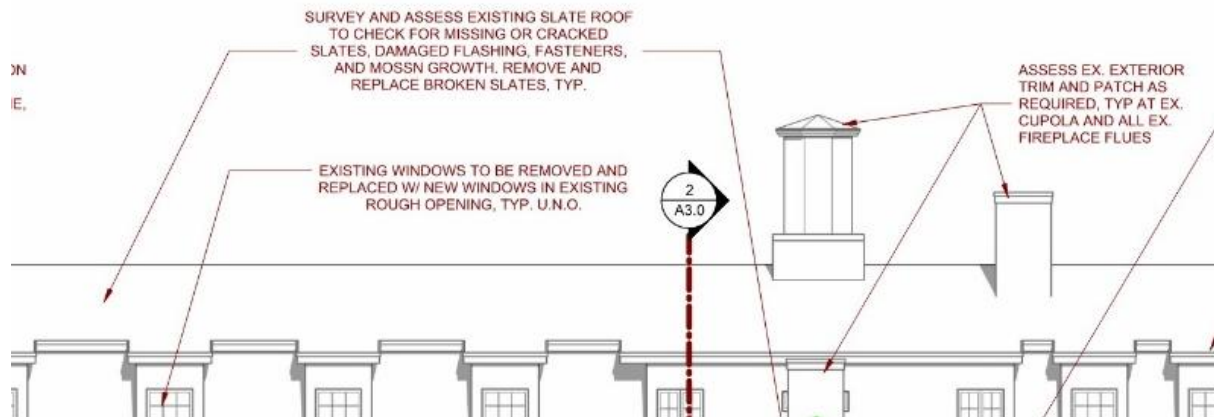
## Roofing

The building roofs are slate and standing seam metal extending to the time of construction with some more recent asphalt roofing added. They are functioning but in need of detailed inspection and repairs as required. The pitched and gambrel roofs feature accessible roof attics which are uninsulated and ventilated by gable end wall louvers and several large roof monitor ventilators.

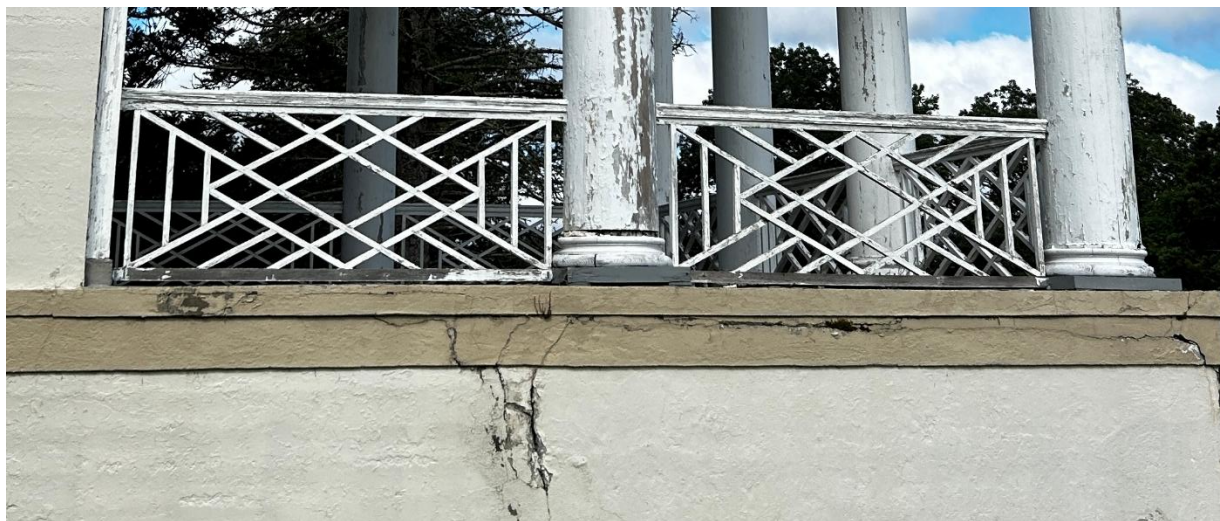
## Exterior Porches

All exterior porches are showing significant weathering and minor degradation. Minor to moderate repairs and repainting and refinishing is required.

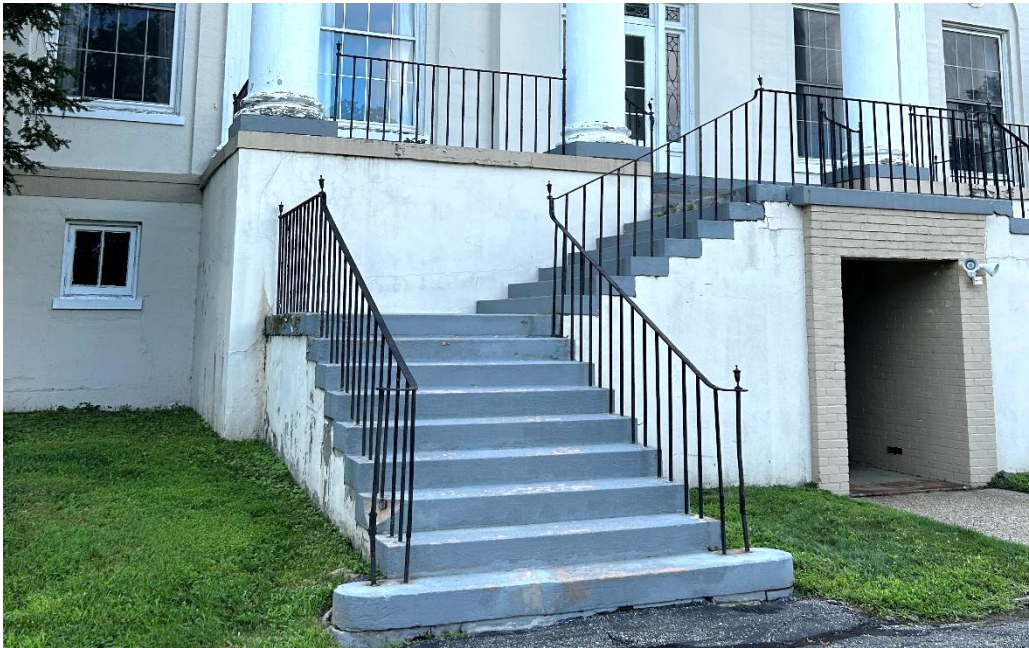
### Exterior Railings / Iron Work

The original exterior iron railings show significant rust and deterioration. Handrails, balustrades, and base plates require major repairs or complete replacement. Wood railings require minor repairs and refinishing.

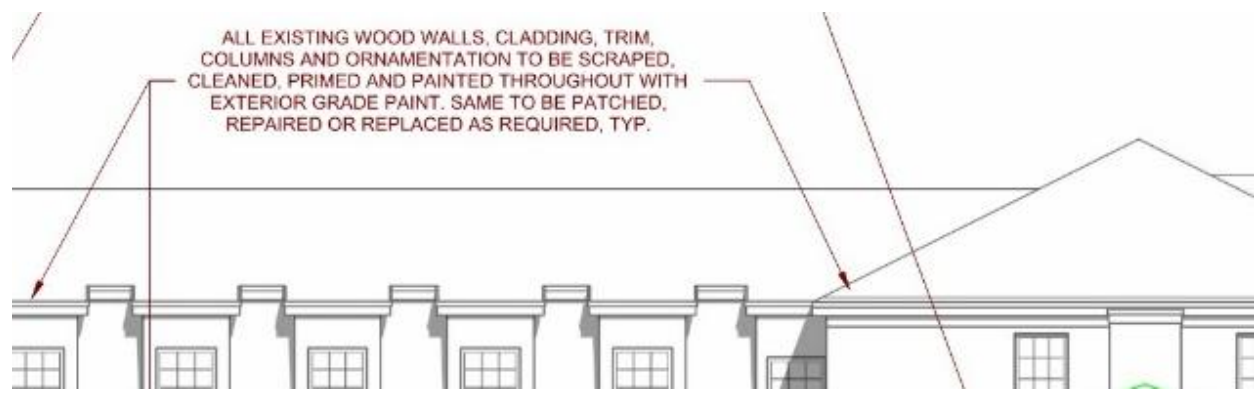
### Exterior Trim and Ornamentation

Exterior wood trim including cornices, pediments, columns, fascias, etc. is generally in good condition and requires minor repairs and cosmetic upgrades. There are some areas, typically at the porches, that require moderate to major repairs.

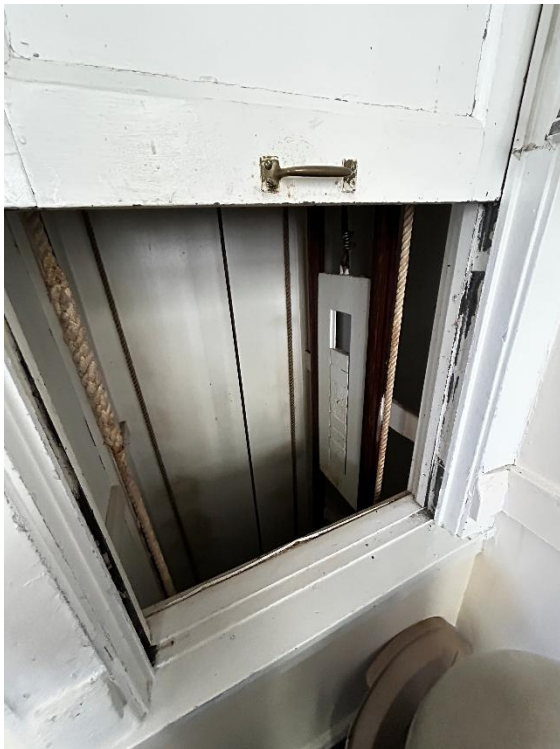
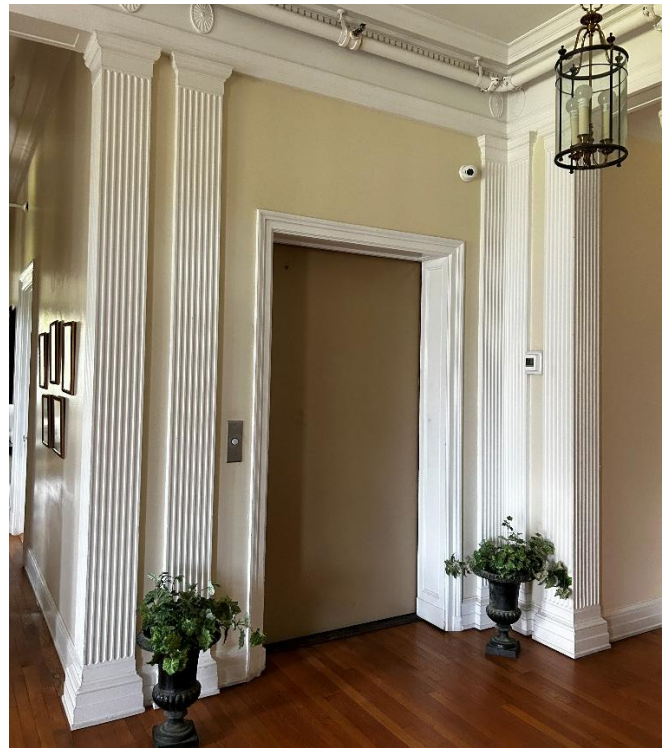
## Vertical Circulation

There is an existing 3-stop passenger elevator that is currently in use, however it is at least 50 years old. While the shaft and available space for elevator equipment are re-useable, any adaptive re-use of the building would require a new elevator cab, lifting mechanisms, and controls. Re-use of existing elevator rails, hoist beams and other structural elements would require further inspection for potential re-use. There is also a non-functioning dumb waiter lift from the basement to the first floor.

With the exception of the exterior open handicapped platform lift, there is little in the building to accommodate accessible use. The platform lift has reached the end of its useful life and should be demolished. A new and fully comprehensive strategy for accessibility is required for any adaptive re-use scenario.
