FIELD HOME FINAL REPORT

Yorktown Heights Field Home

(Yorktown, NY)

30 December 2025

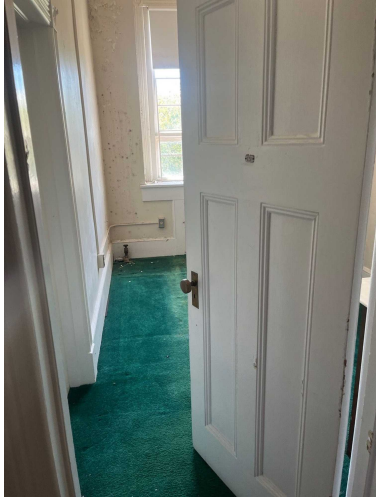
Date taken: 07/15/2025
Floor 2 front room 19

- Room #19 in the front center area of the second floor had water damage and suspect visible mold growth present. A tape lift sample was taken from the plaster wall surface, and it is considered **unacceptable**.

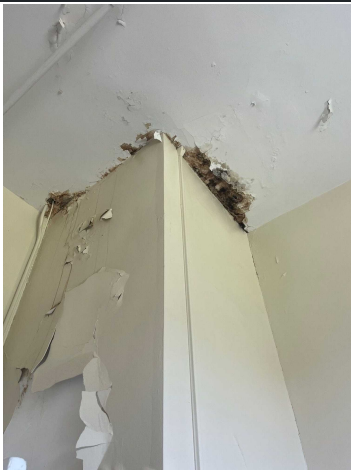
Date taken: 07/15/2025
Floor 2 right rear bathroom

- The right rear bathroom had water damage, peeling paint, and suspect visible mold present on the upper wall and ceiling. A tape lift sample was taken from the upper wall and it is considered **unacceptable**.

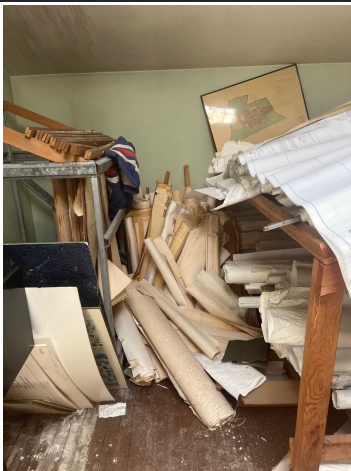
Date taken: 07/15/2025
Center stair plan room

- The rear main stairwell had a room (plan/blueprint room) off the middle landing. The wood flooring and plaster walls, and ceiling were water-damaged. A tape lift sample was taken from the floor to assess for settled mold spores, and the sample is considered **acceptable**.

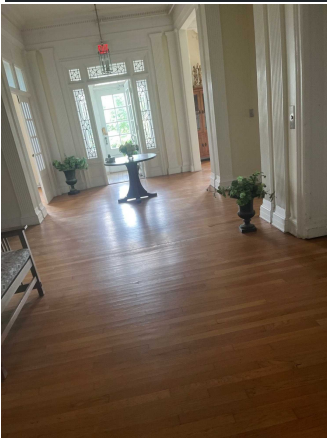
Floor 1 far left

- The remainder of the first floor was clean and free of debris. The main center hall had occupied offices, and the far left hall was very clean and free of debris, water damage, and visible mold growth. The left front area of the far left hall was a conference room that was occupied by several people. This area appeared to have been recently remodeled or kept in **excellent condition**. Tape lift samples were taken from the floors in the far left hall and the left side of the main hall. The sample taken from the floor in the far left hall is considered acceptable. The sample taken from the floor on the left side of the main hall is considered **unacceptable**.

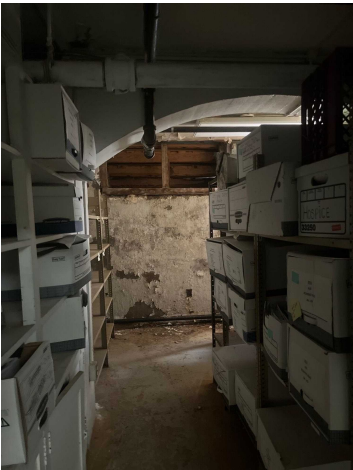
Basement front under stairs

- The basement had limited contents and debris present. The left front area and the area below the stairs had cardboard boxes present. These boxes appeared to have been recently placed in storage. The remainder of the basement had water damage, water staining, and damage to the plaster wall and ceiling materials in the front center room. Mold in air samples were taken from the left, center, and right sides of the basement, and all samples are considered **unacceptable**.

- The basement should have all recently placed cardboard boxes and any other contents that will be saved placed in a separate containment. All remaining contents should be removed and discarded. All water-damaged plaster, wall, and ceiling materials ~500 sq. ft. should be removed and discarded.
